Featured Project: Guildford Museum

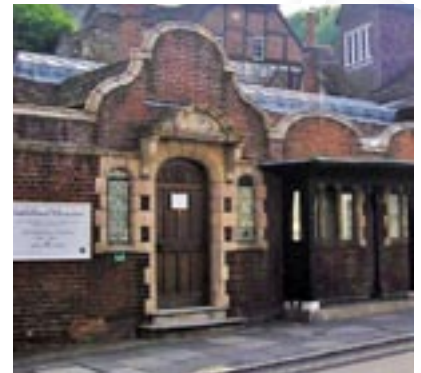
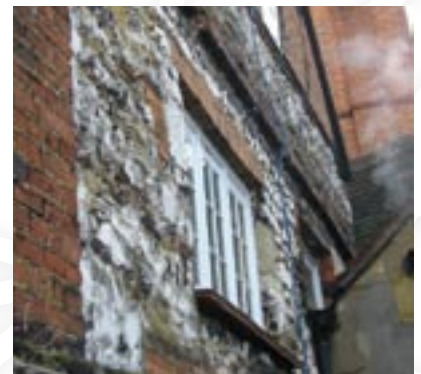
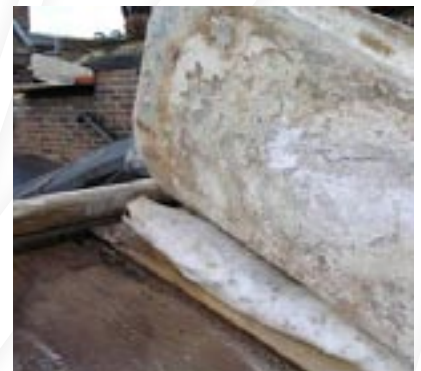
During a periodic maintenance inspection the previous year the Maddisons surveyor noticed several splits and holes to leadwork coverings on the museum roof. Despite the lead having been replaced only 15 years ago we were concerned that it showed signs of premature failure and suggested further investigation.

Upon opening up the lead was found to have thinned to only microns in thickness in various places. This was due to excessive corrosion on the underside of the lead from condensation trapped below.

The main technical issues related to the lead work where corrosion had created a white carbonate dust on the underside of the covering. This dust is highly toxic and it was essential that it was prevented from being dispersed into the air, inhaled, or ingested by persons within close proximity.

Maddisons were initially commissioned to undertake a measured survey of the building and to prepare detailed plans and elevations for the Council’s records. We were then appointed to prepare a specification and schedule of remedial works, to procure tenders and supervise the works on site.

Careful risk assessment and a method statement for safe removal of the lead was therefore essential and to assist in this a regime of 'air monitoring' was adopted before, during and on completion of the works.

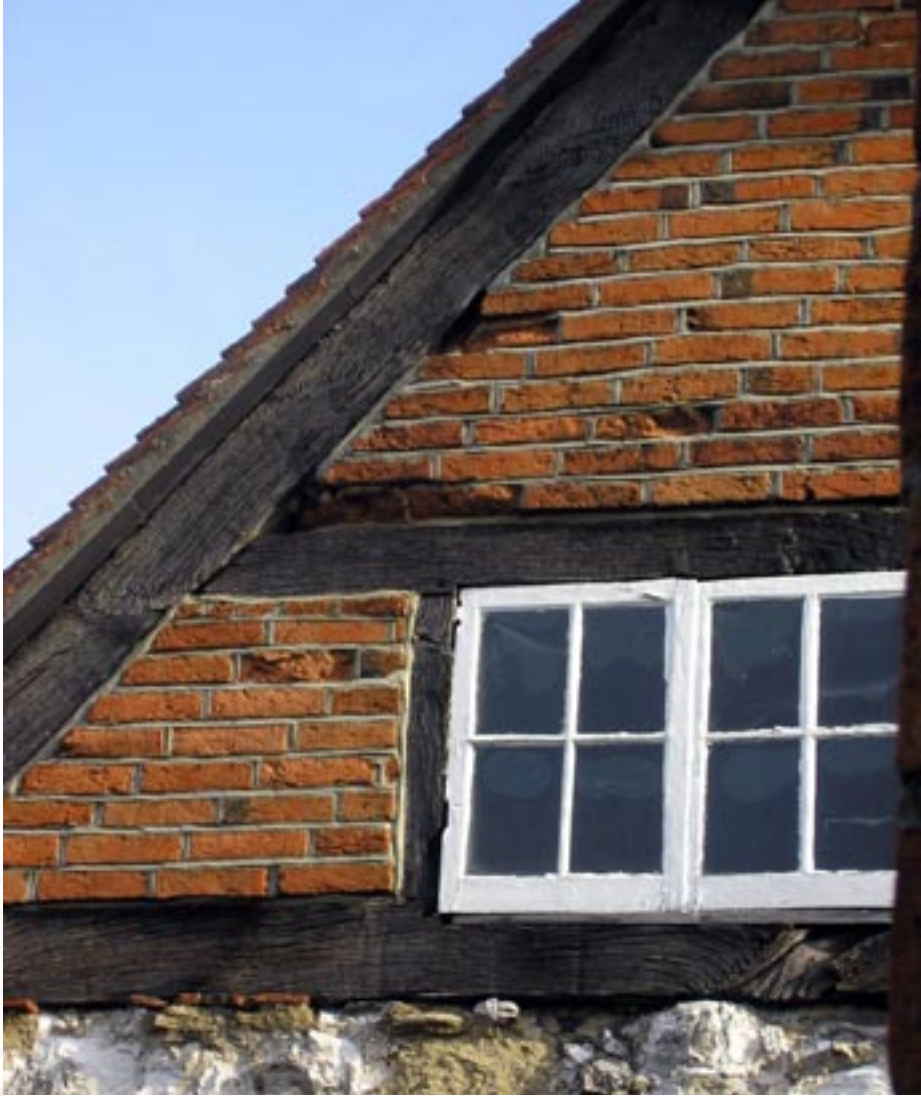
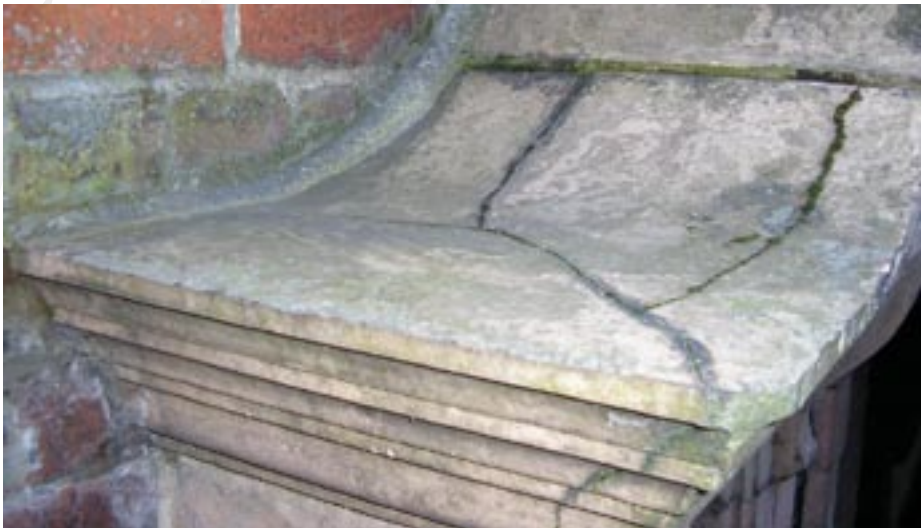
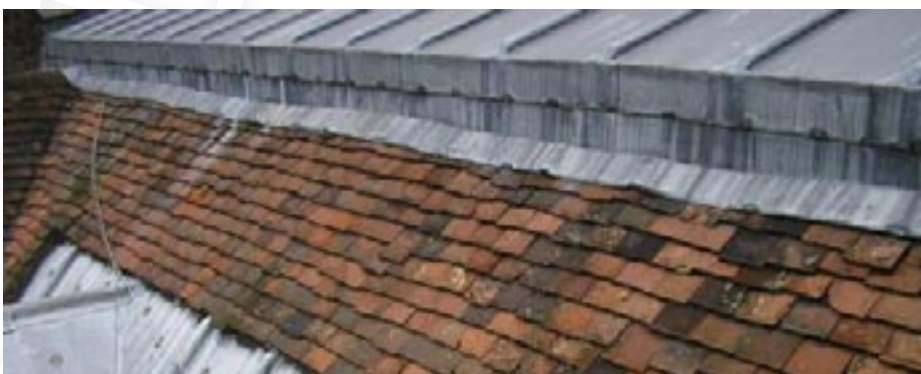
In addition to the lead replacement works a number of ancient timbers had to be repaired or receive preserving treatments. Whilst the roof was stripped it was discovered that air conditioning plant had been built into the void and whilst still live it had been redundant for

many years. Their removal enabled a solution to be designed for cross-ventilation to the roof void.
