Featured Project: Guildford Museum

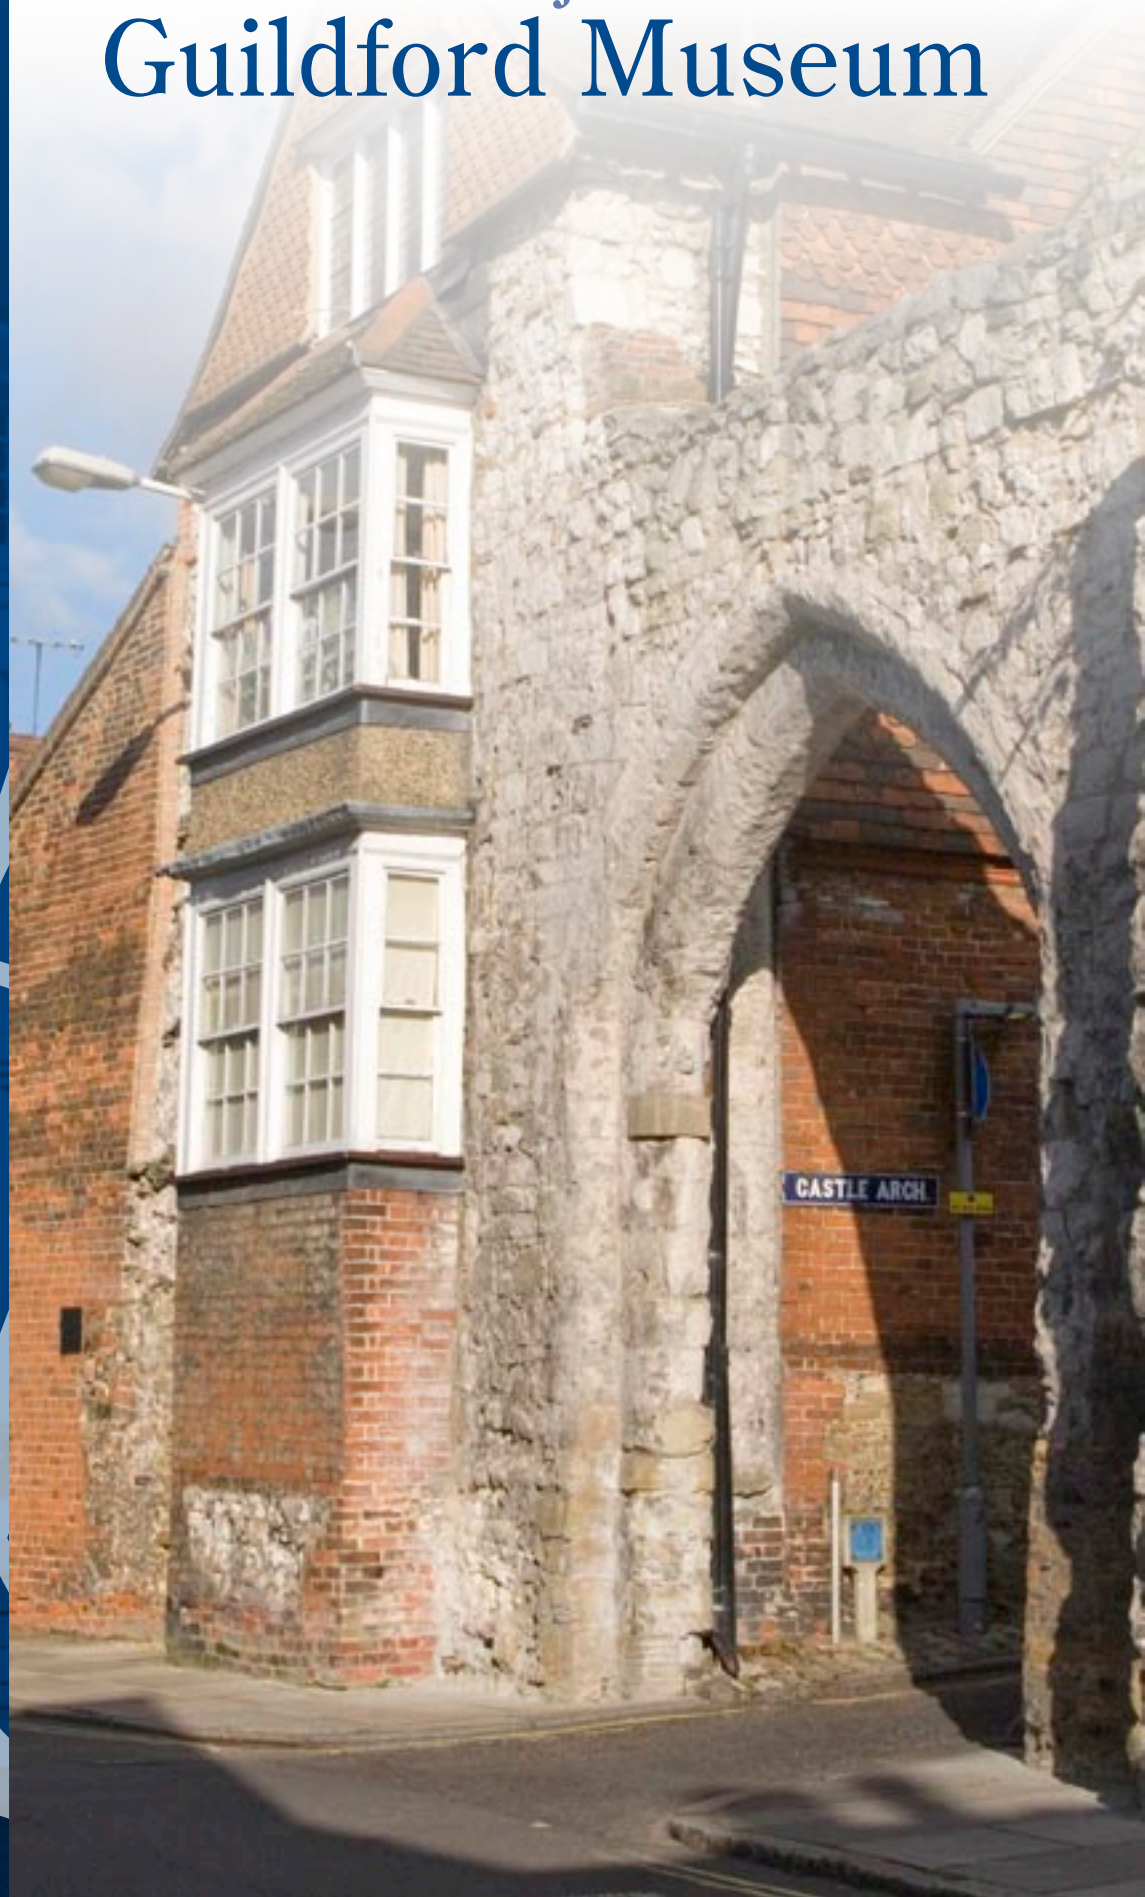
During a periodic maintenance inspection the previous year the Maddisons surveyor noticed several splits and holes to leadwork coverings on the museum roof. Despite the lead having been replaced only 15 years ago we were concerned that it showed signs of premature failure and suggested further investigation.

Upon opening up the lead was found to have thinned to only microns in thickness in various places. This was due to excessive corrosion on the underside of the lead from condensation trapped below.

The main technical issues related to the lead work where corrosion had created a white carbonate dust on the underside of the covering. This dust is highly toxic and it was essential that it was prevented from being dispersed into the air, inhaled, or ingested by persons within close proximity.

Careful risk assessment and a method statement for safe removal of the lead was therefore essential and to assist in this a regime of 'air monitoring' was adopted before, during and on completion of the works.

In addition to the lead replacement works a number of ancient timbers had to be repaired or receive preserving treatments. Whilst the roof was stripped it was discovered that air conditioning plant had been built into the void and whilst still live it had been redundant for

many years. Their removal enabled a solution to be designed for cross-ventilation to the roof void.
